# **KeContact P30**

## **Software release notes Package 1.4**

Author: brc      Version date: 24.03.2017

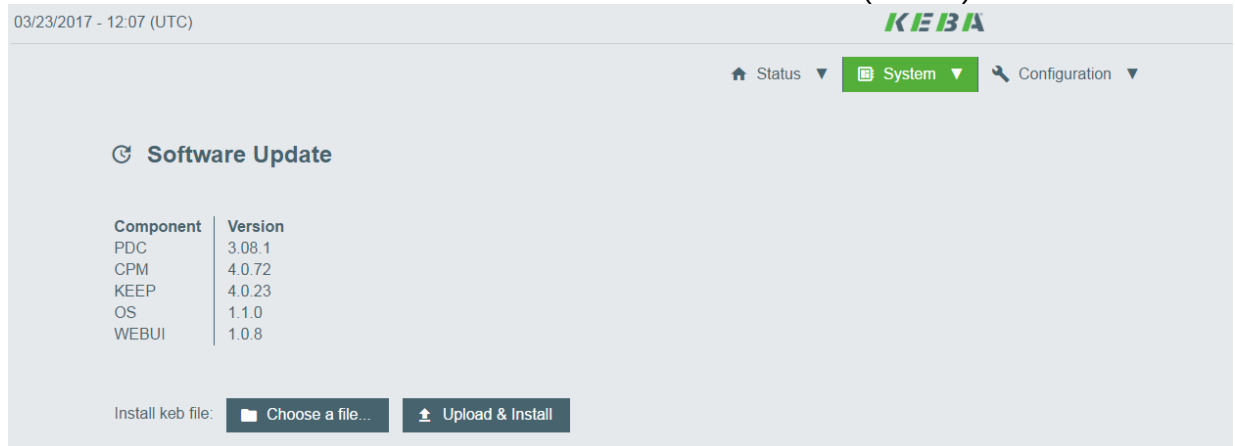
The software version 1.4 can be read on the web based interface (WebUI).

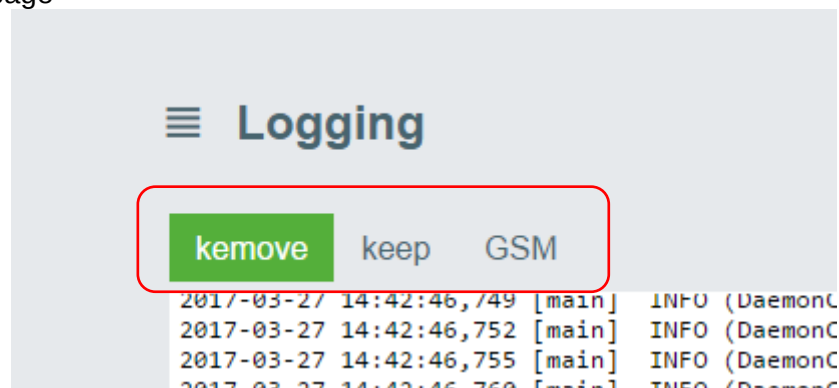
New web page

#### 2.2.1. Unused logs have been removed

Unused tabs like "kremove-wrapper" and "keep-wrapper" have been removed from the logging web page.

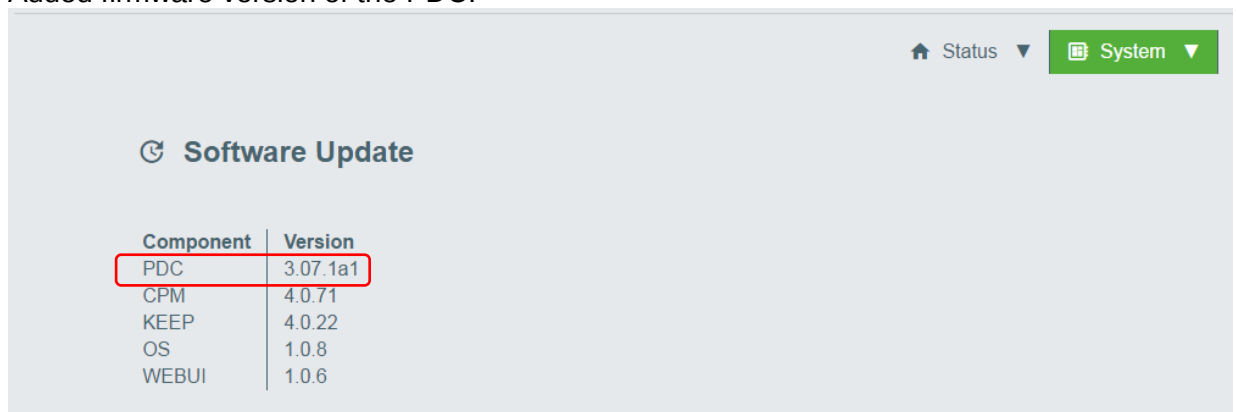
### 3.3.4. WebUI – visualisation of firmware

Added firmware version of the PDC.
