# **KeContact P30**

## **Software release notes Package 1.5**

Version date: 13.10.2017

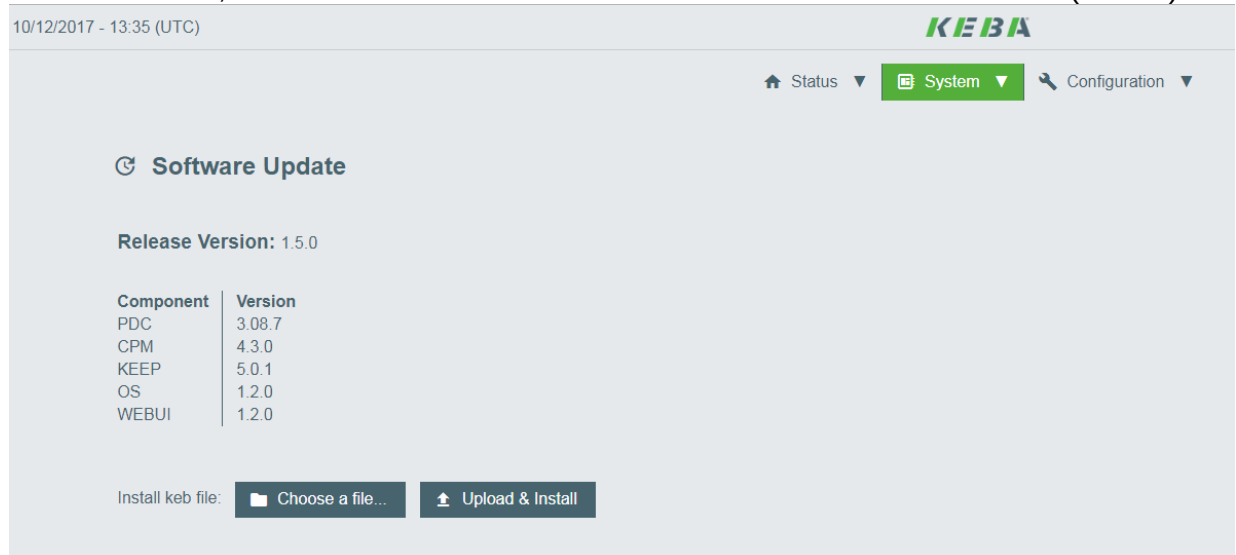
After installation, the software version 1.5 can be read on the web based interface (WebUI).

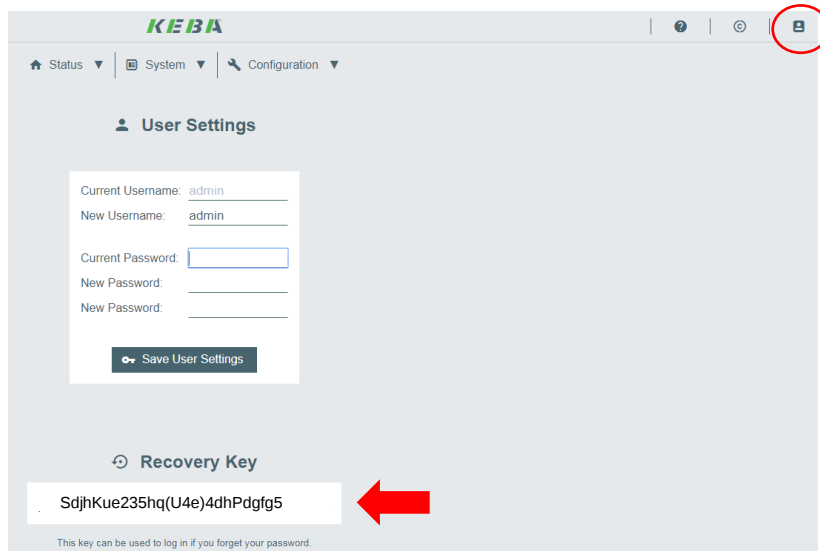
In case you forget your password, you can use the unique recovery key of your P30 x-series to reset the password.

You can find your recovery key in the User settings.

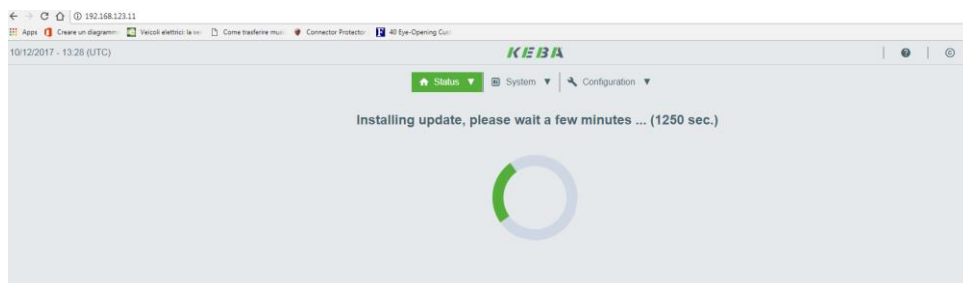
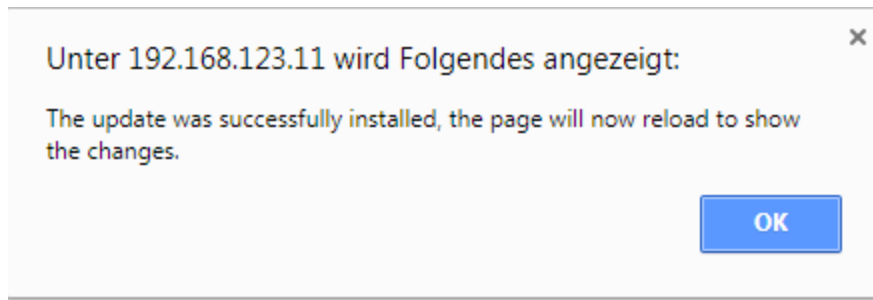
The visual feedback during update has been improved. The WebUI shows the actual status of the update and provides feedback on whether the update has been successfully completed. During the update the 4 LED segments flash orange (breathing mode).

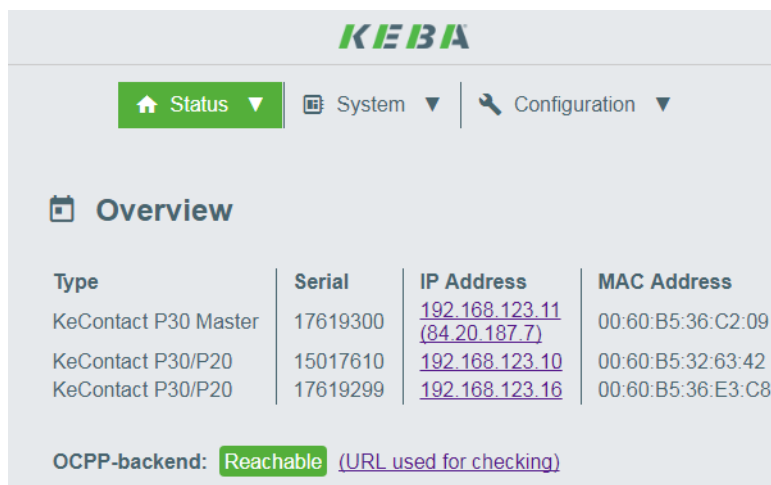
In the overview section of the WebUI the IP Addresses and MAC Addresses of the master and slave wallboxes are shown.

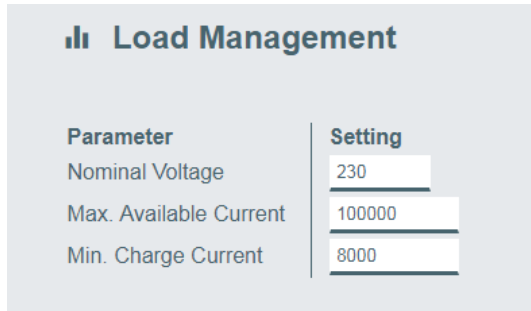
It is now possible to select the value of the maximum or minimum current and input a new value.

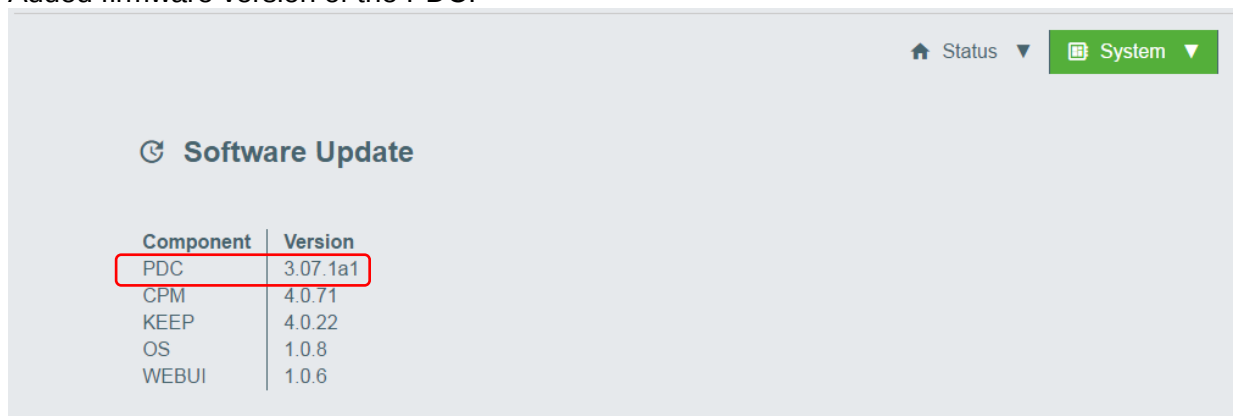
Added firmware version of the PDC.

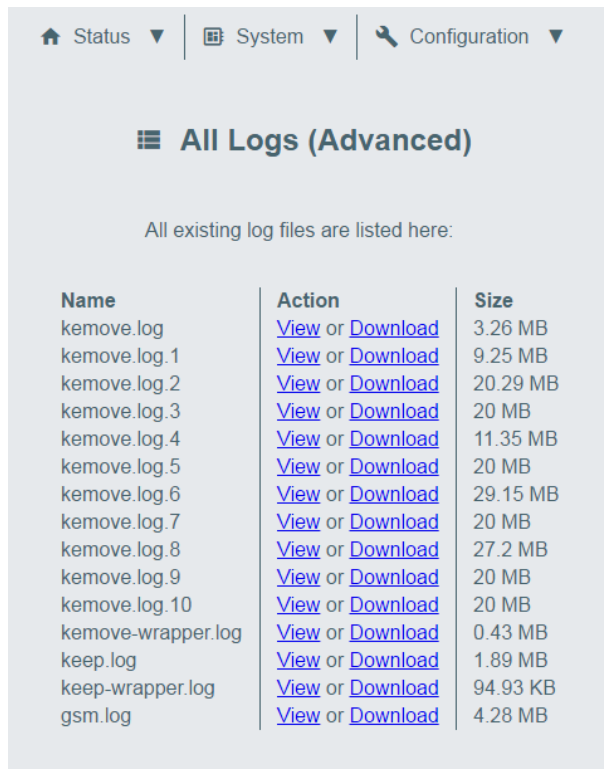
Here is shown a screen shot of what the user can see if clicking on “ All Logs”.

The screenshot shows a web interface with a top navigation bar containing 'Status', 'System', and 'Configuration' tabs. Below the navigation bar is a section titled 'All Logs (Advanced)'. Under this title, it says 'All existing log files are listed here:'. Below this is a table with three columns: 'Name', 'Action', and 'Size'. The table lists various log files, including 'kemove.log', 'kemove.log.1' through 'kemove.log.10', 'kemove-wrapper.log', 'keep.log', 'keep-wrapper.log', and 'gsm.log'. Each row has a 'View' or 'Download' link in the 'Action' column and a size in the 'Size' column.

Added "All Logs" button to "Logging" tab, allows individually viewing and downloading every single log file.

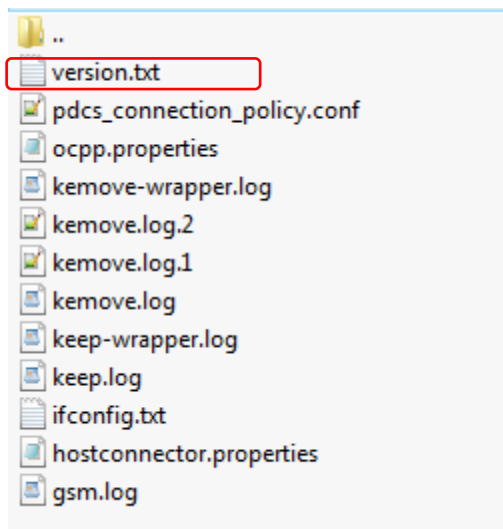
Added the text file “version.txt” in zip file accessible by clicking on "Download Latest".

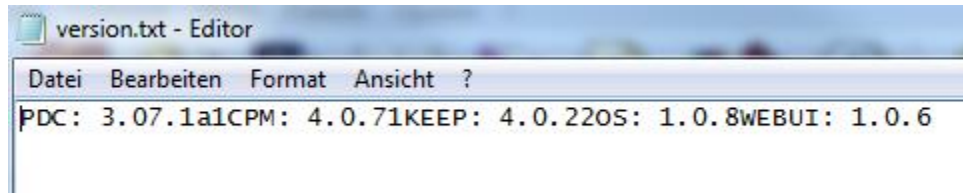
In this file are enclosed the information related to the versions of the software component.
