# **KeContact P30**

## **Software release notes Package 1.6.3**

Version date: 16.04.2018

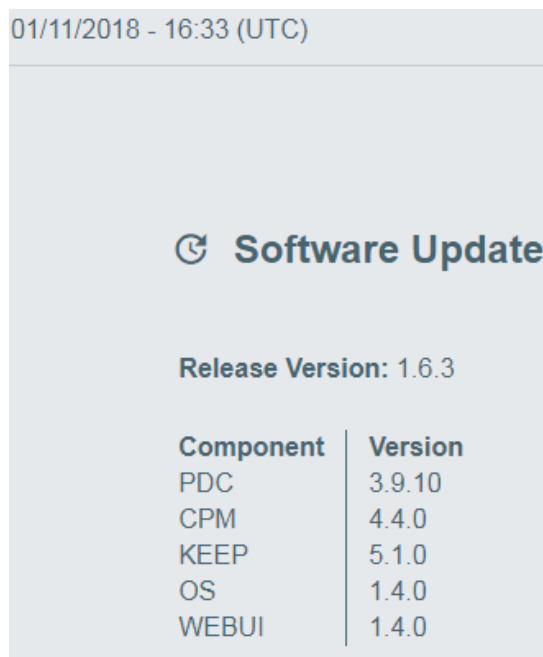
After installation, the software version 1.6.3 can be read on the web based interface (WebUI).

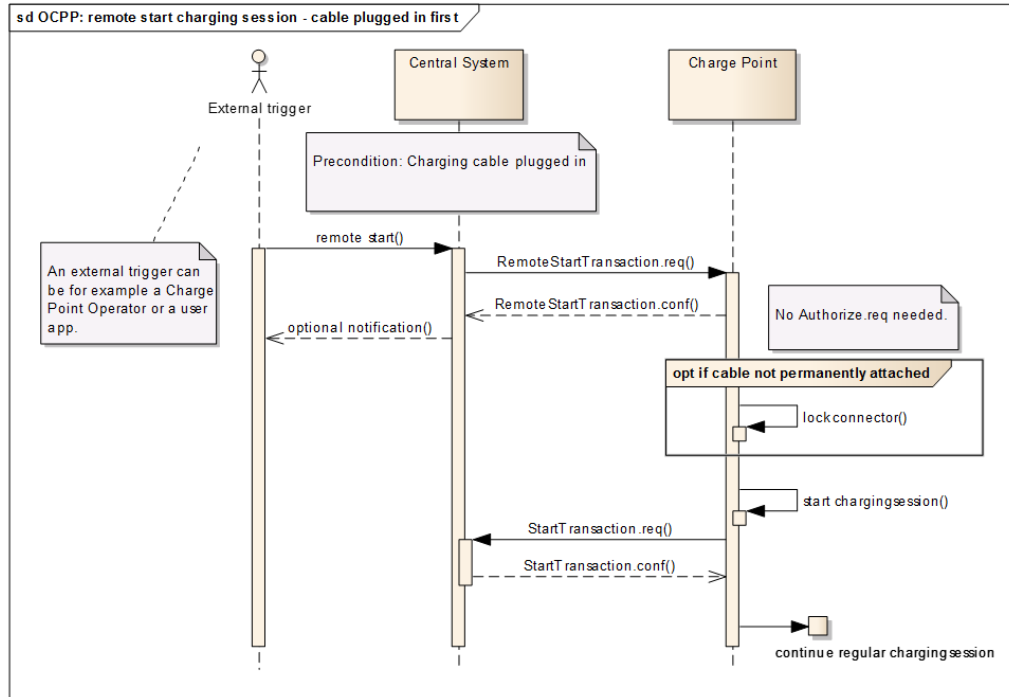
#### Remote start charging session – cable plugged in first

The Remote Start Transaction sequence has been modified so that the P30 replies immediately after receiving the Remote Start Transaction request.

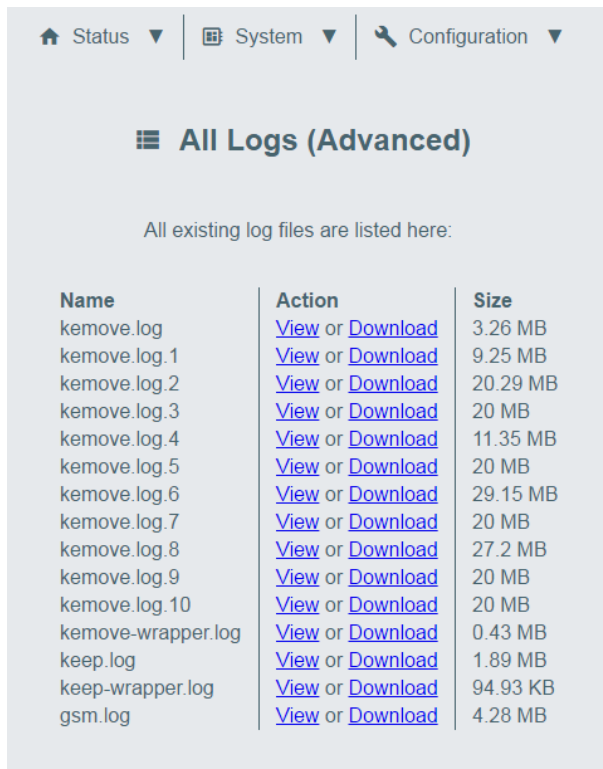
Added "All Logs" button to "Logging" tab, allows individually viewing and downloading every single log file.

Here is shown a screen shot of what the user can see if clicking on “ All Logs”.

The screenshot shows a web interface with a top navigation bar containing 'Status', 'System', and 'Configuration' tabs. Below this is a section titled 'All Logs (Advanced)'. A message states 'All existing log files are listed here:'. Below the message is a table with three columns: 'Name', 'Action', and 'Size'. The table lists various log files, including 'kemove.log', 'kemove.log.1' through 'kemove.log.10', 'kemove-wrapper.log', 'keep.log', 'keep-wrapper.log', and 'gsm.log'. Each row provides a 'View' or 'Download' link in the 'Action' column and the file size in the 'Size' column.

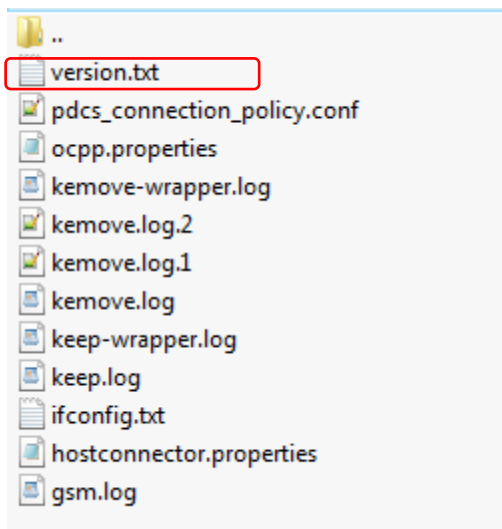
Added the text file “version.txt” in zip file accessible by clicking on "Download Latest".
