# **KeContact P30**

## **Software release notes Package 1.7**

Version date: 01.08.2018

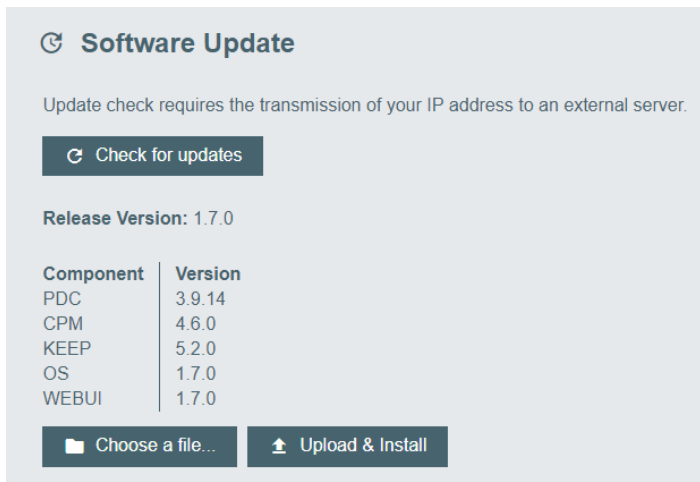
After installation, the software version 1.7 can be read on the web based interface (WebUI).
